# A HIGH POWER LOW VOLTAGE SWITCHBOARD FAILURE

Russell Lee FIEAust CPEng

- This short presentation discusses the failure of a Main Switchboard which was connected to a supply authority transformer without upstream low voltage protection. The switchroom could not be entered for some hours after the event occurred due to the high temperatures generated by the arcing faults.

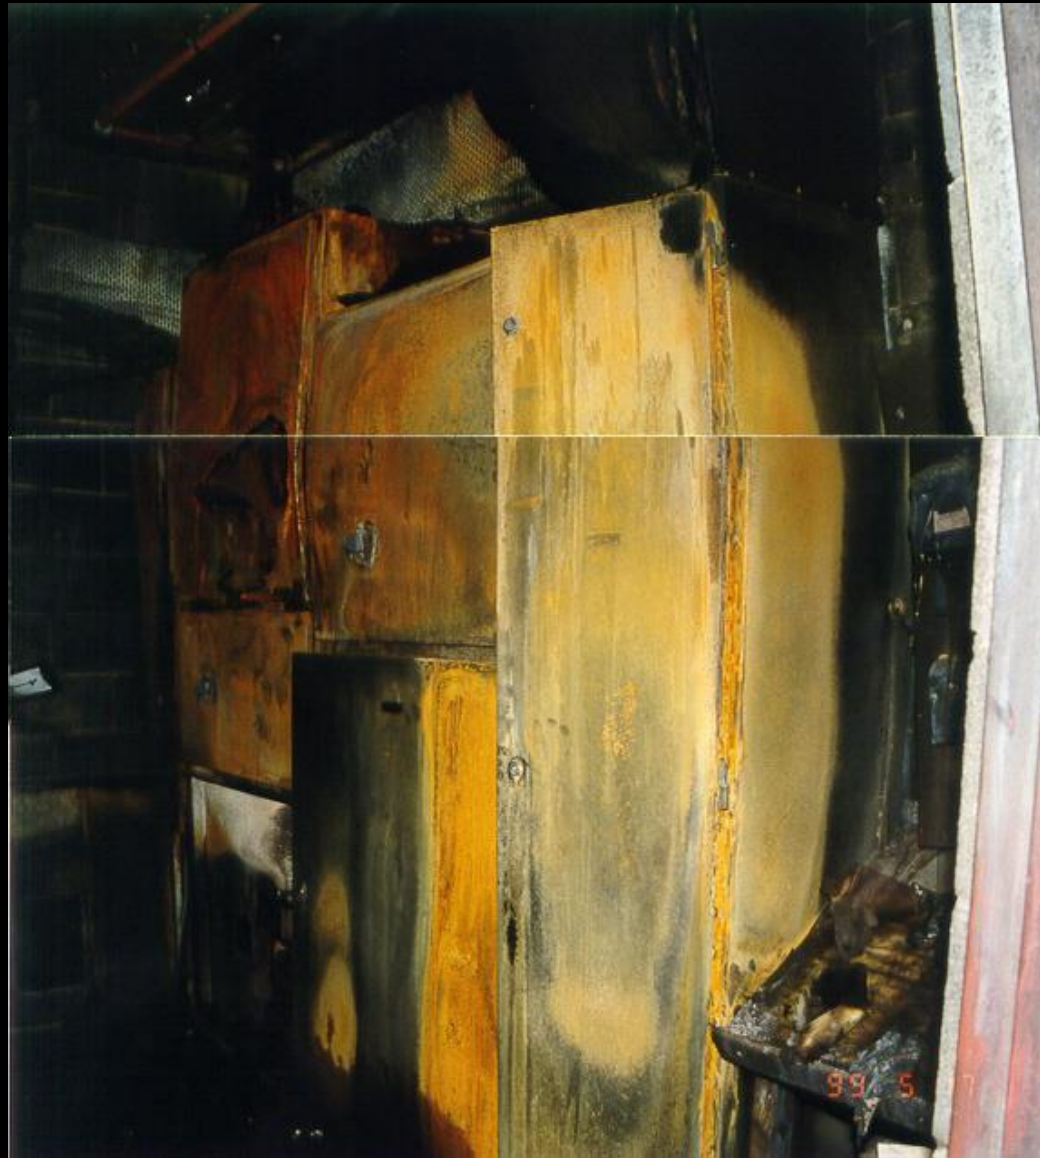
# The Switchroom

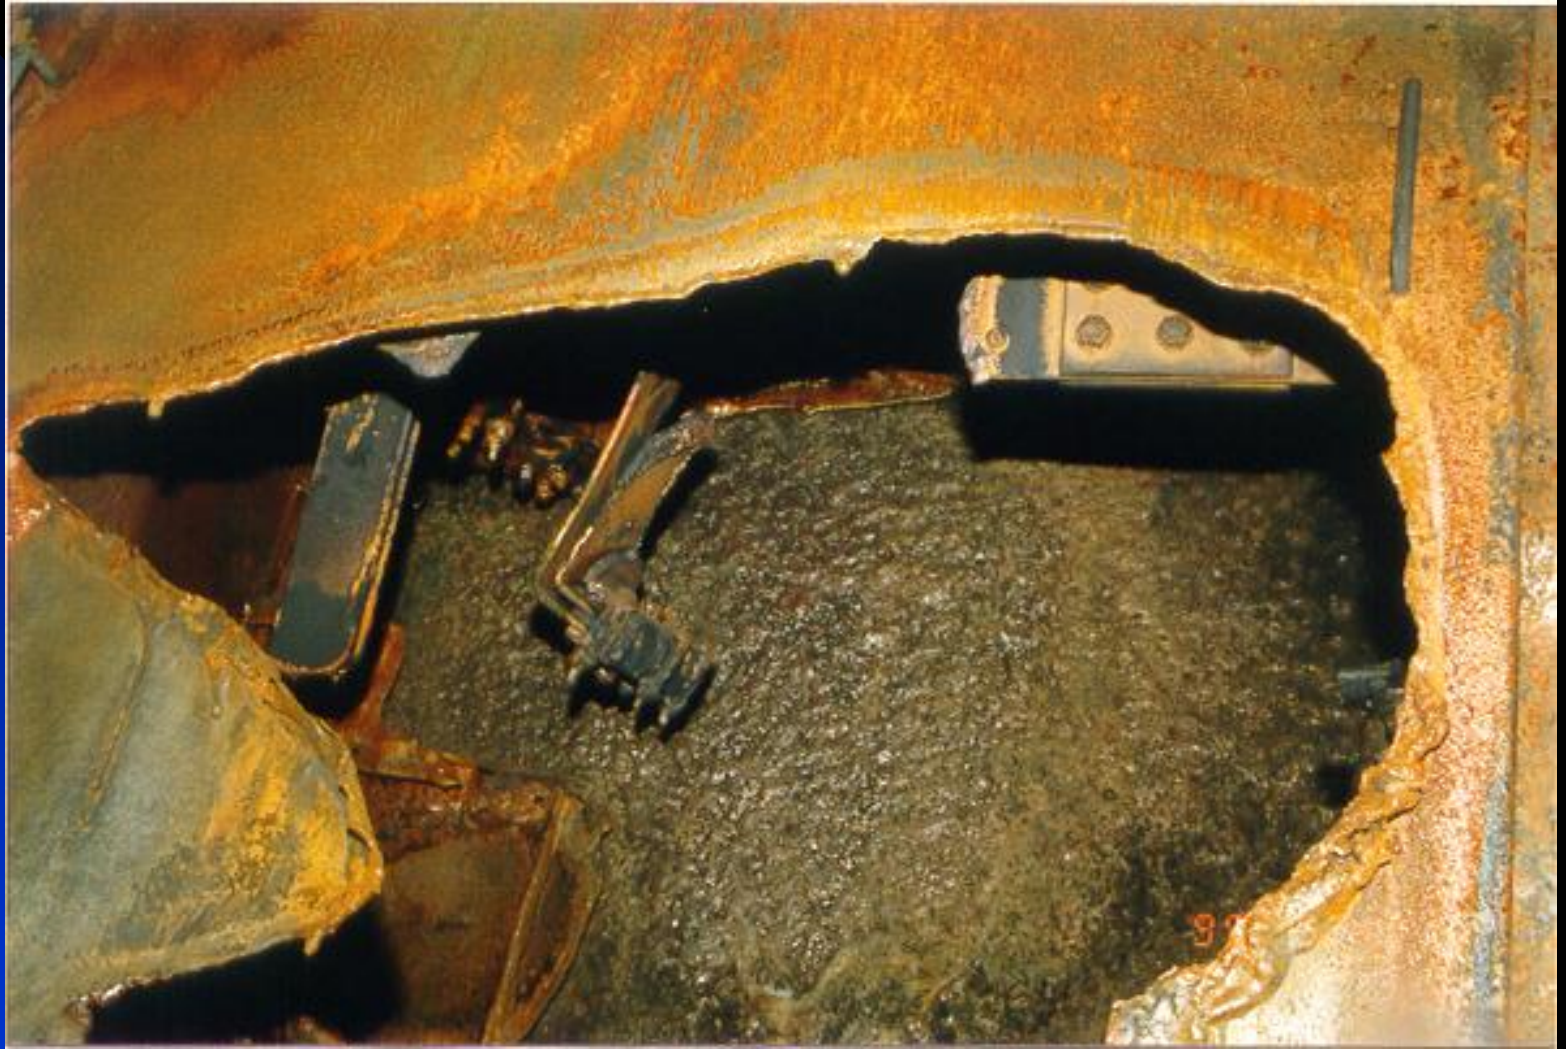
# Arc Penetrations of the Enclosure. Metering Panel

- The arcing events penetrated the metal enclosure front and back.
- A person standing in front of the switchboard would suffer serious burns.
- Other apparatus in the room would suffer serious heat attack, and contamination by copper and iron oxides, and chlorine compounds from the combustion of plastics.
- The power supply was off for many hours. The new switchboard took days. Standby power was used during the interim.

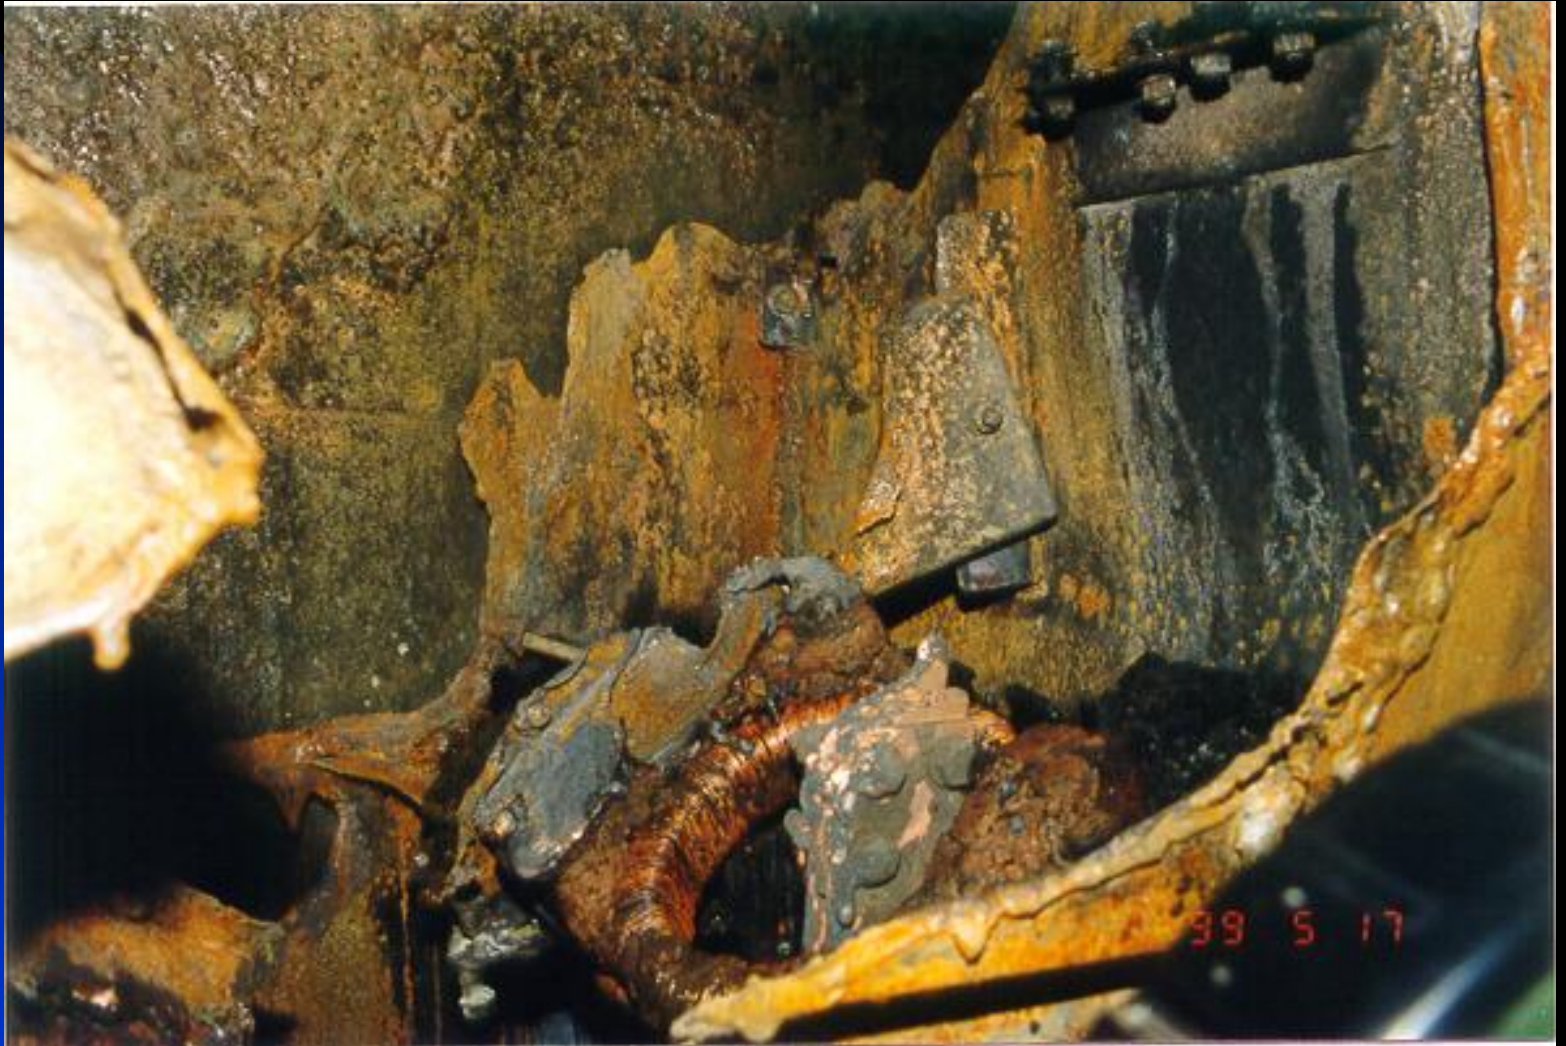
# Arc Penetrations of the Enclosure. Metering Panel

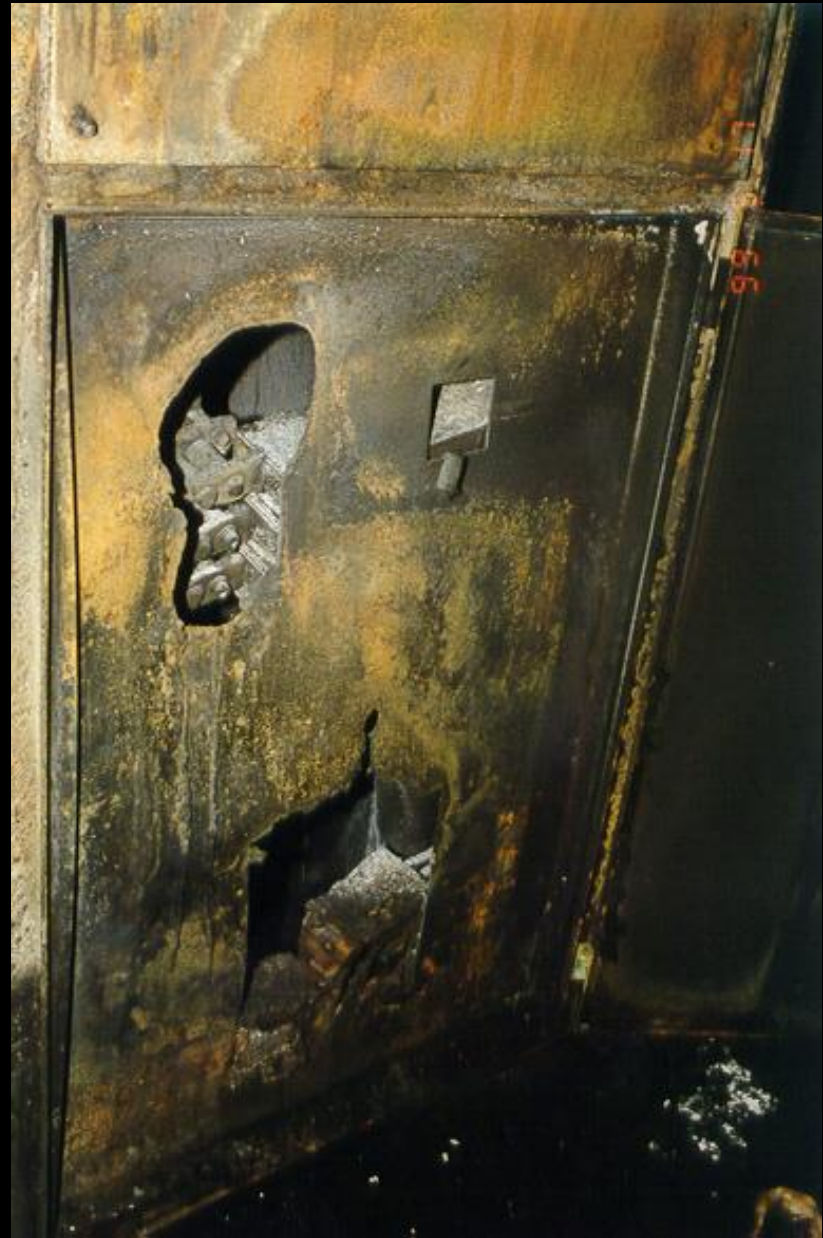
# Secondary Arc Penetrations

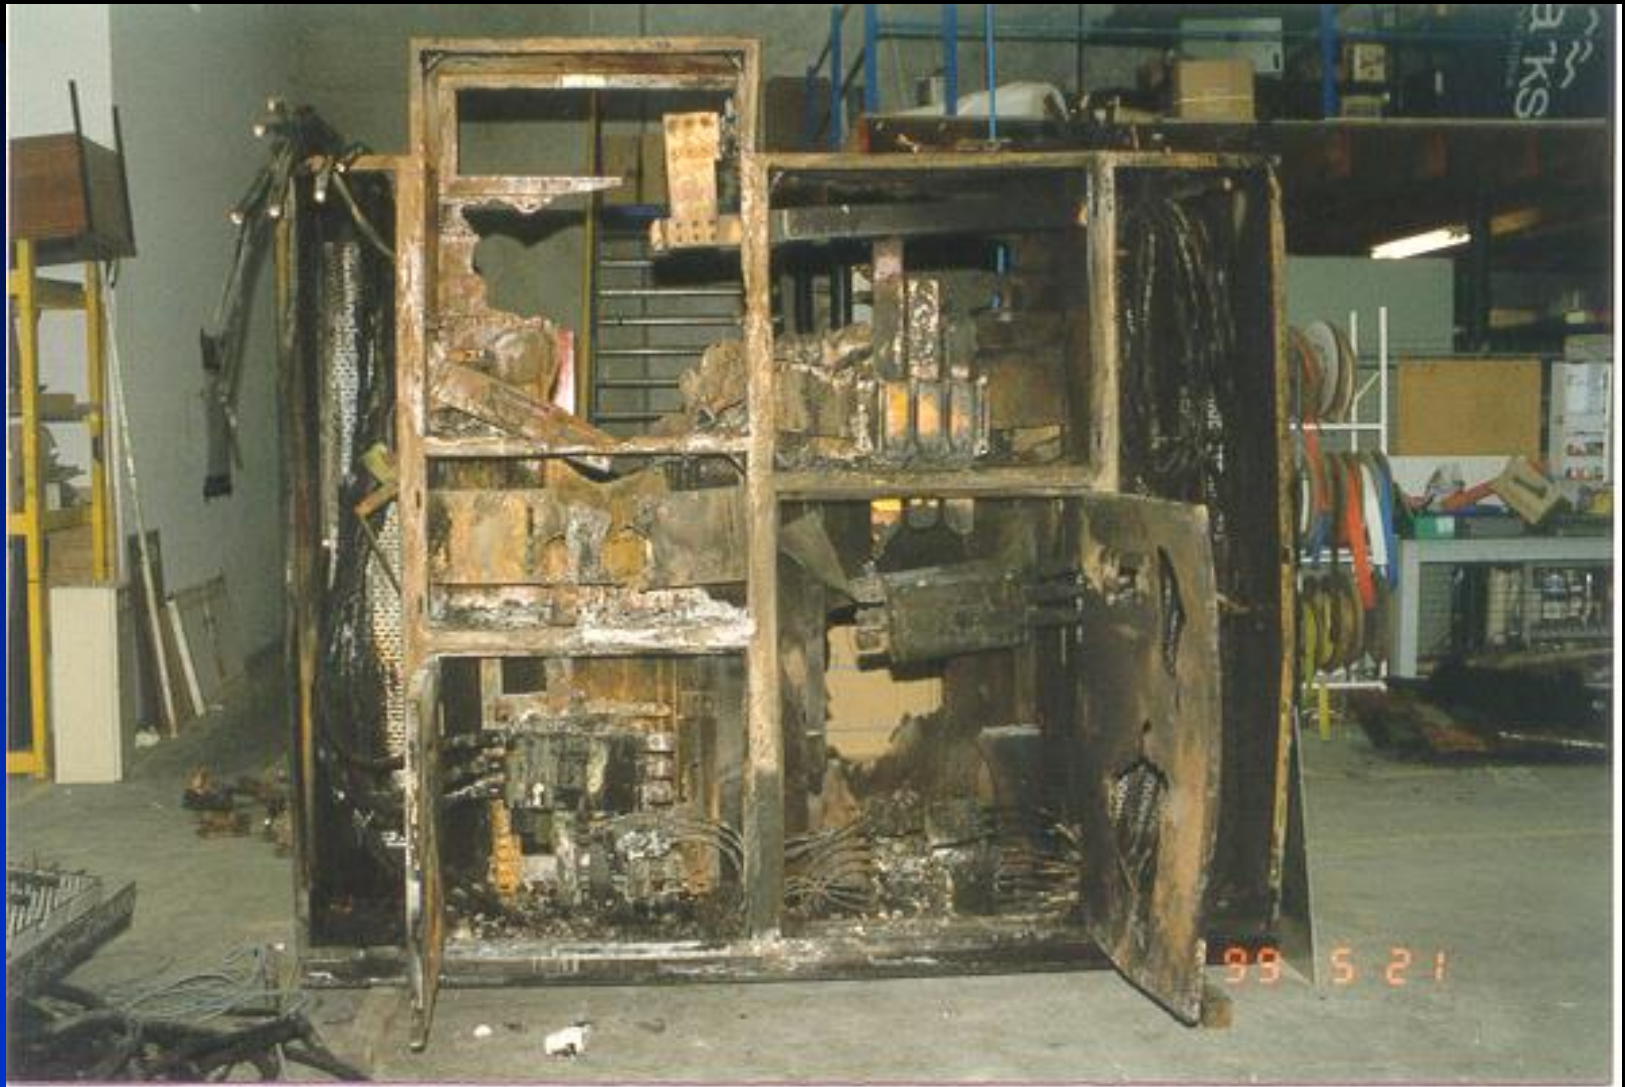
# The front of the Swbd exposed

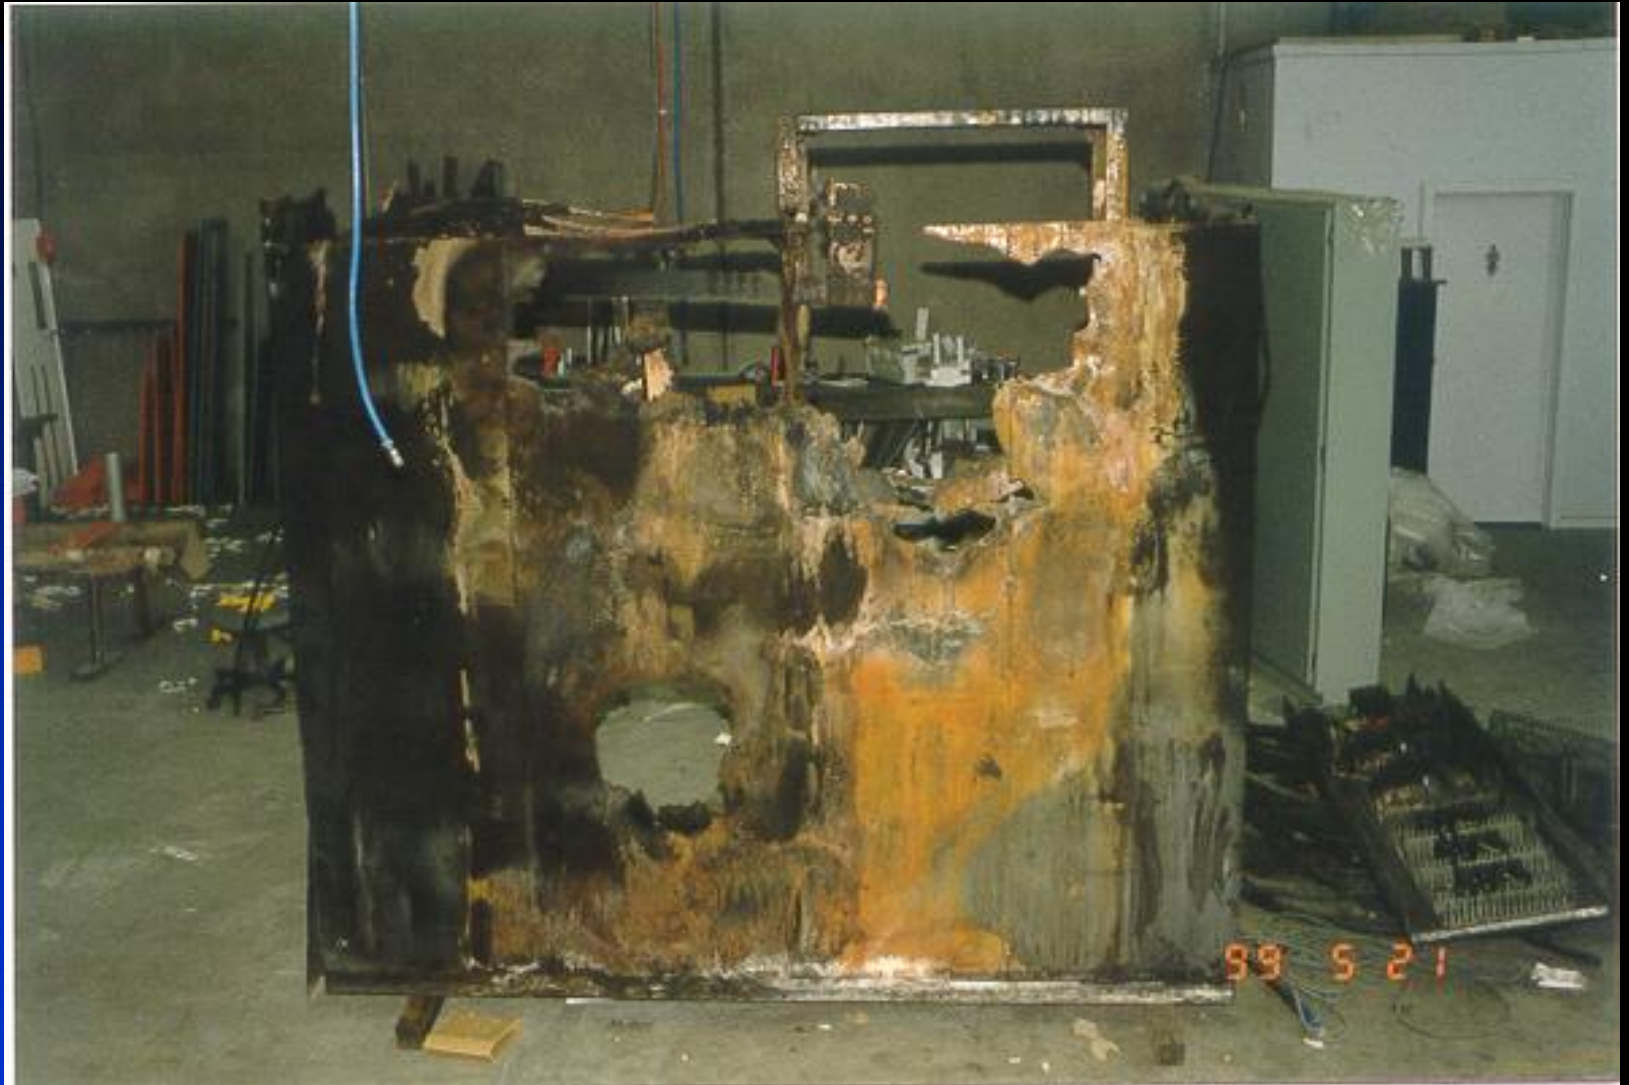
# The rear of the Swbd exposed

- The switchboard was subdivided into compartments.
- There was no fault containment between compartments.
- The electrical upstream protection was on the high voltage side of the supplying transformer, and was set to protect the transformer only. Not the switchboard.
- The arcing faults burnt for some seconds, and were impedance limited.

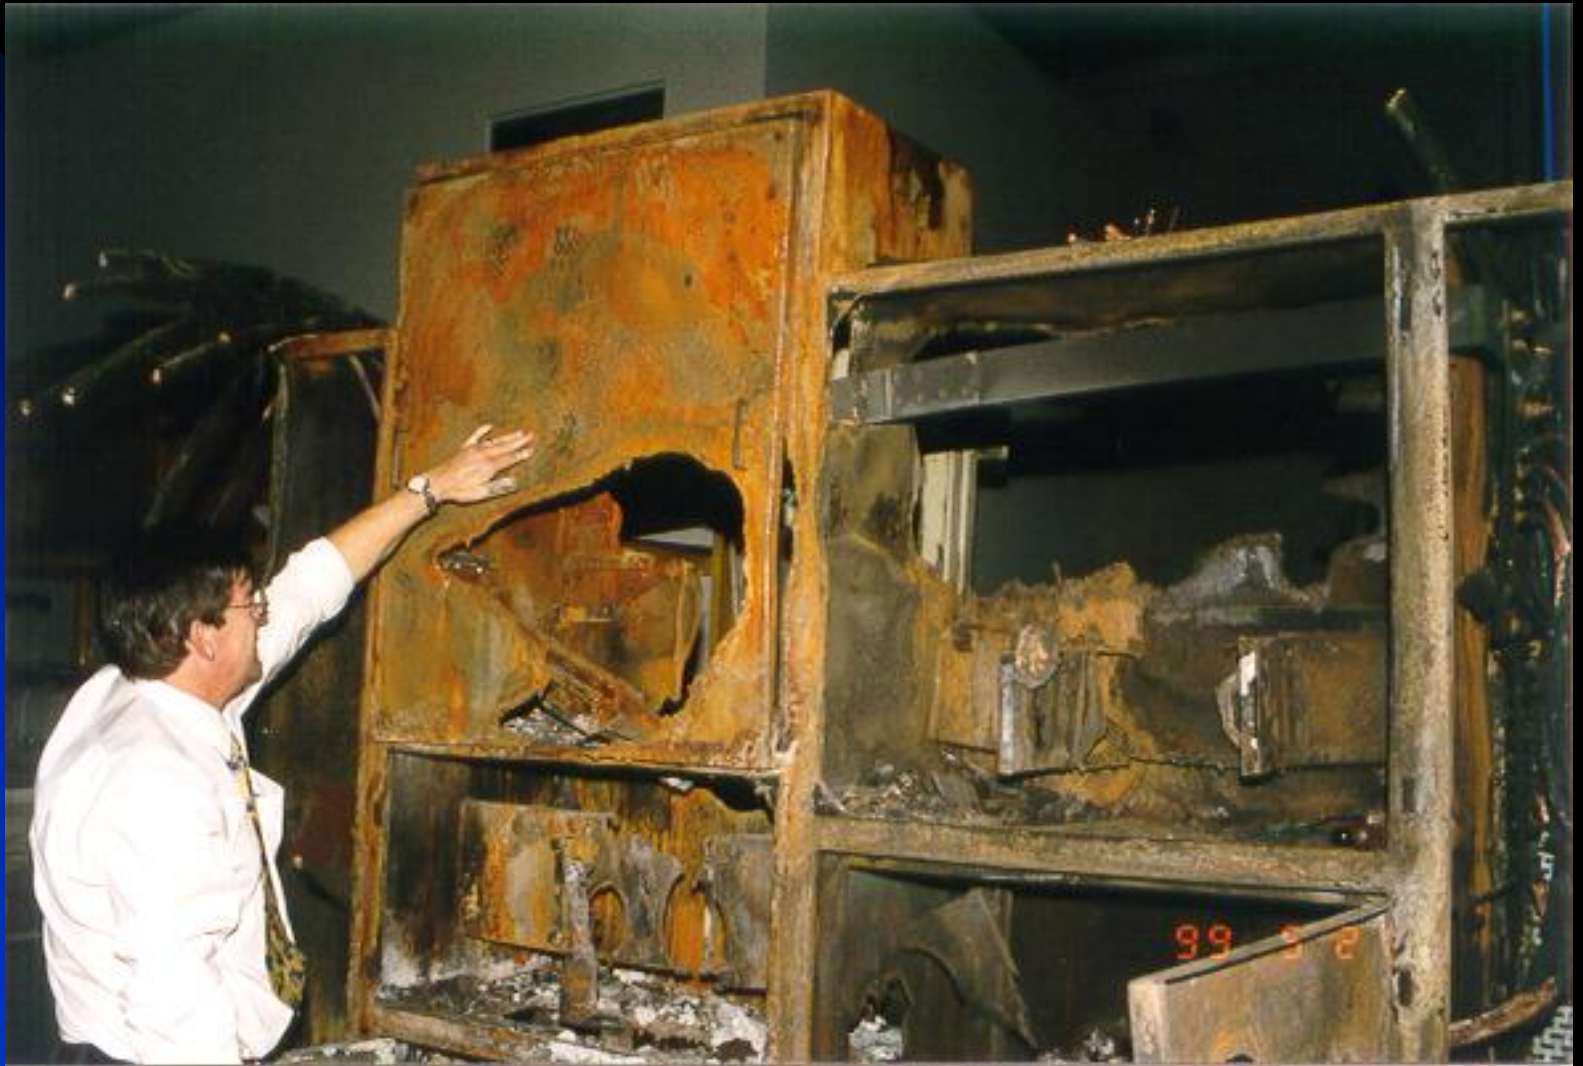
# Locating the Origin of Failure

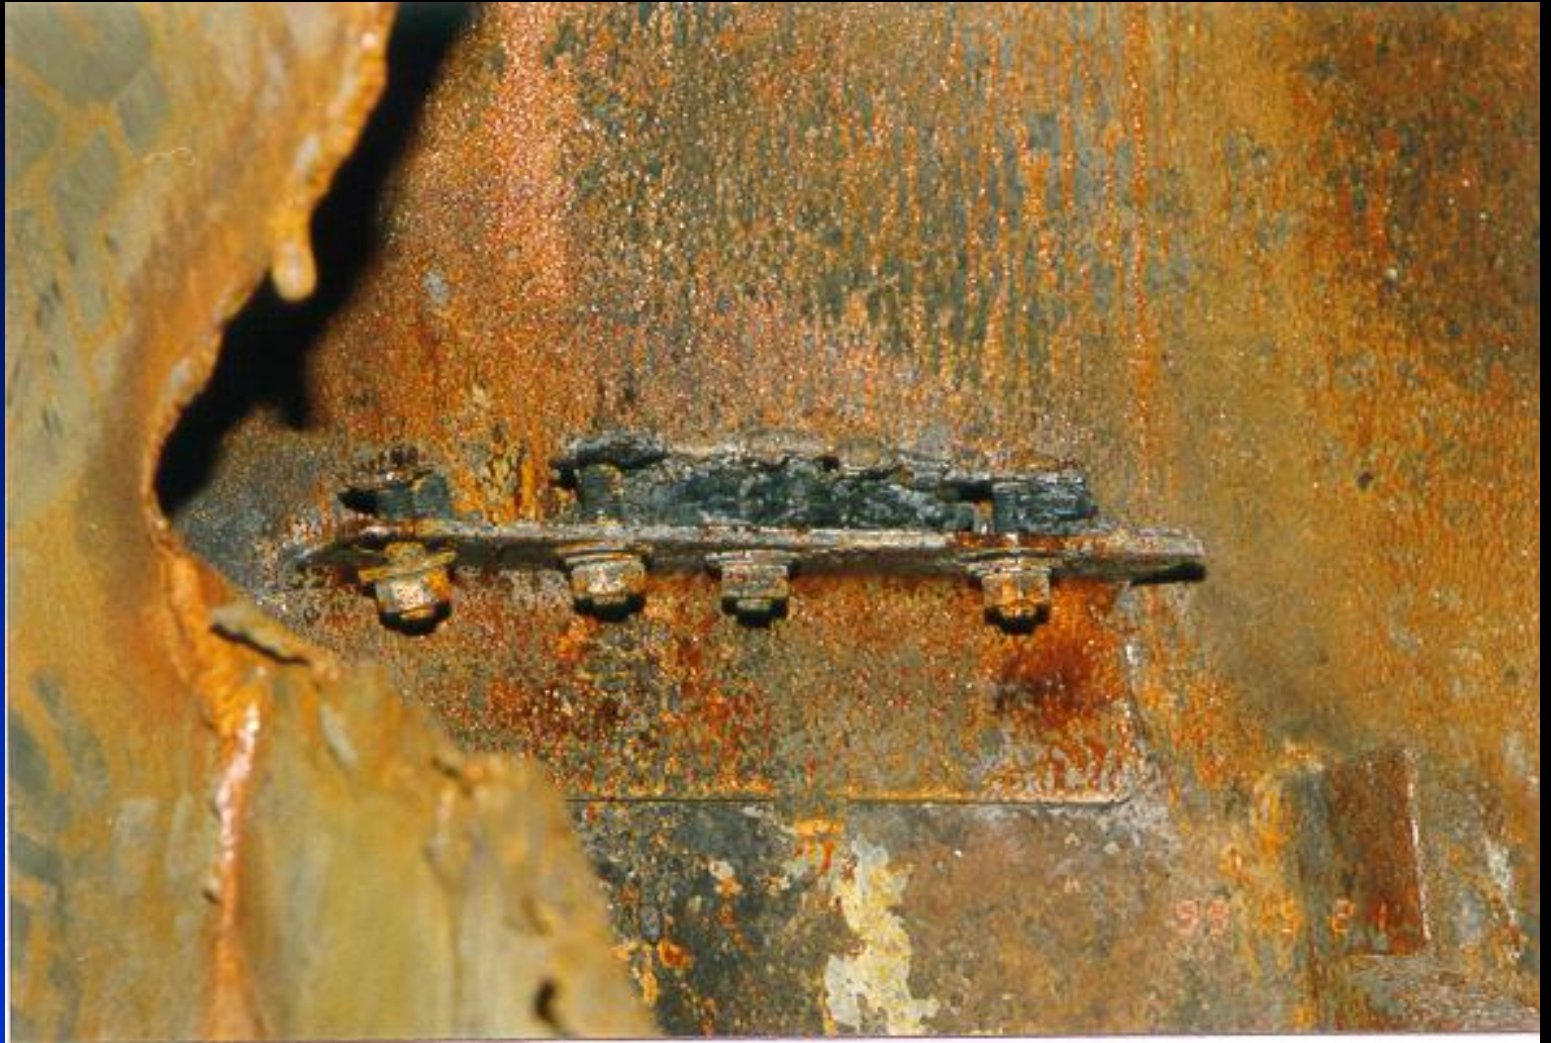
# The Origin of Failure

- The initial failure was due to the collapse of a current transformer metering the incoming supply.
- The initial fault was reflected by the insulating panel supporting busbars immediately below the position of the current transformers.
- The fault was deflected sideways to penetrate the adjoining compartment which was connected to supply above the current transformers

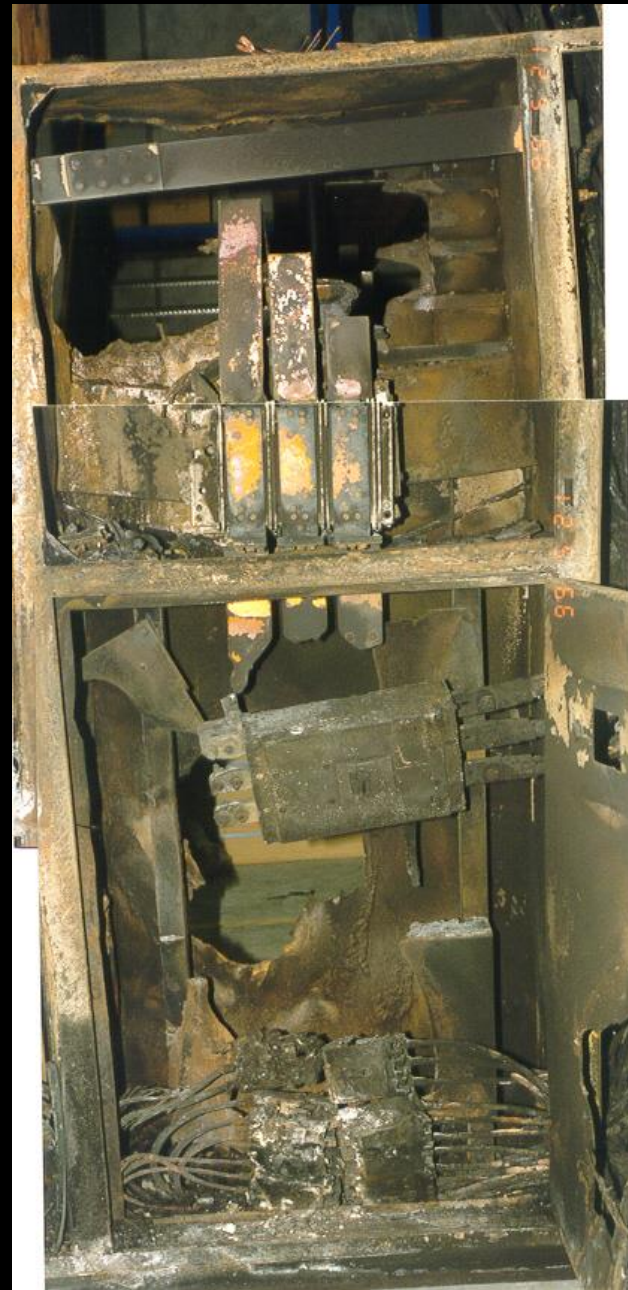
# The Secondary Damage

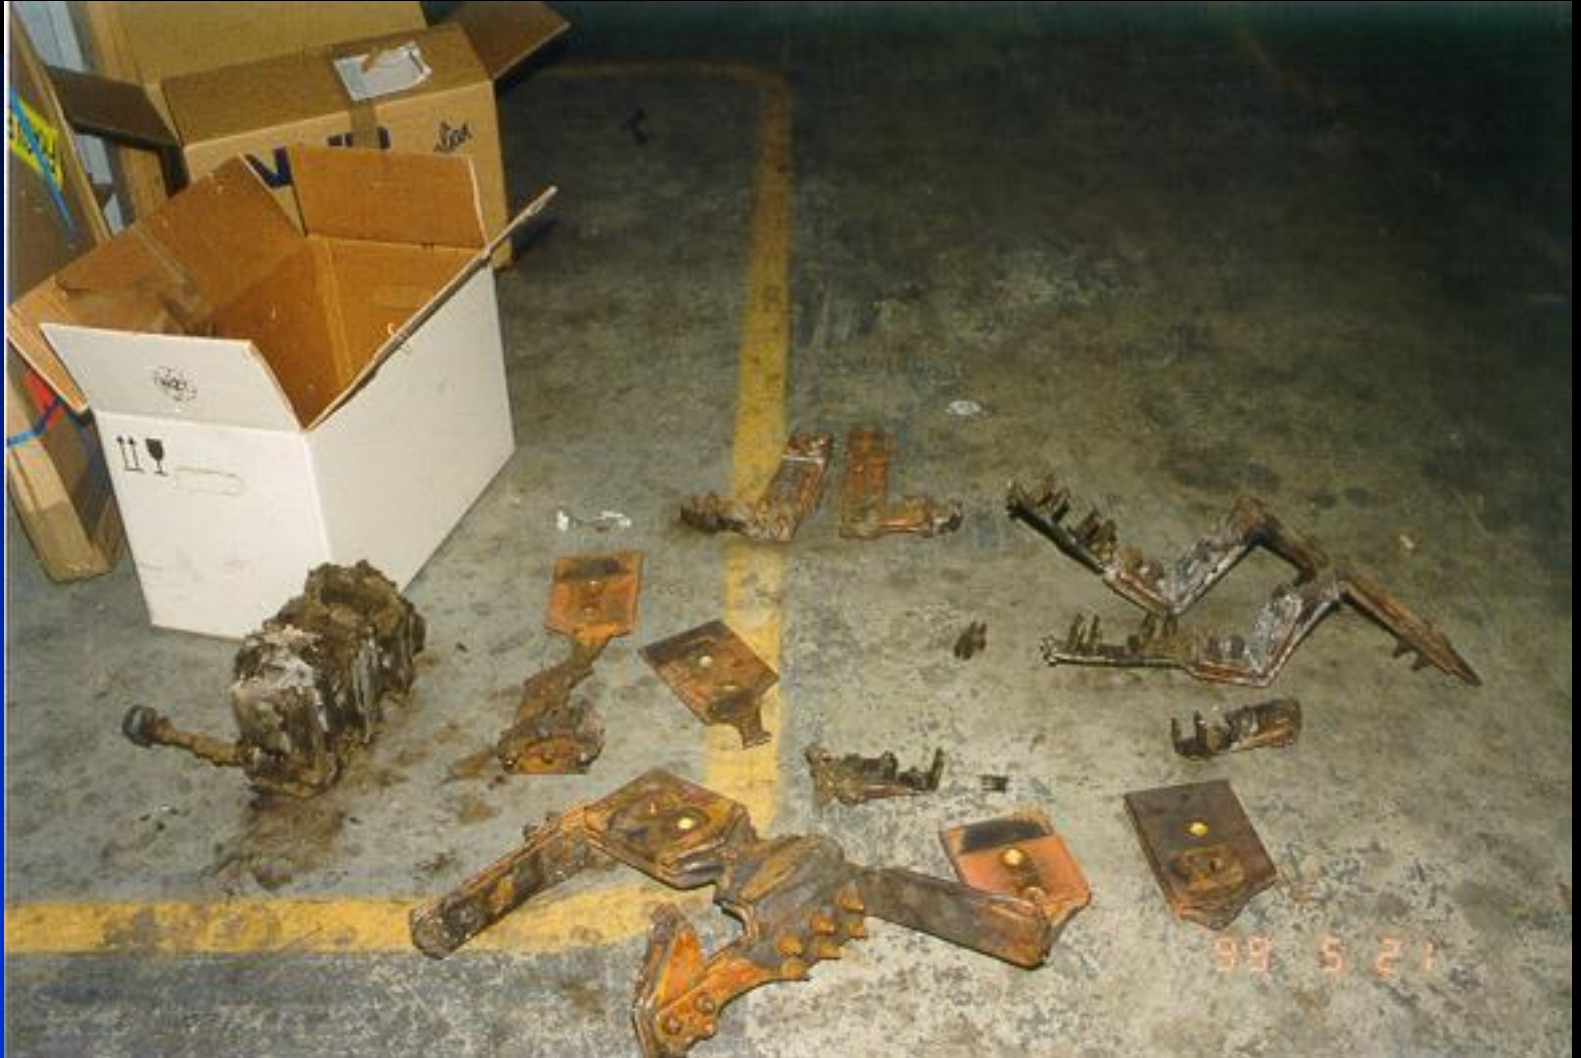
# Erosion of Busbars

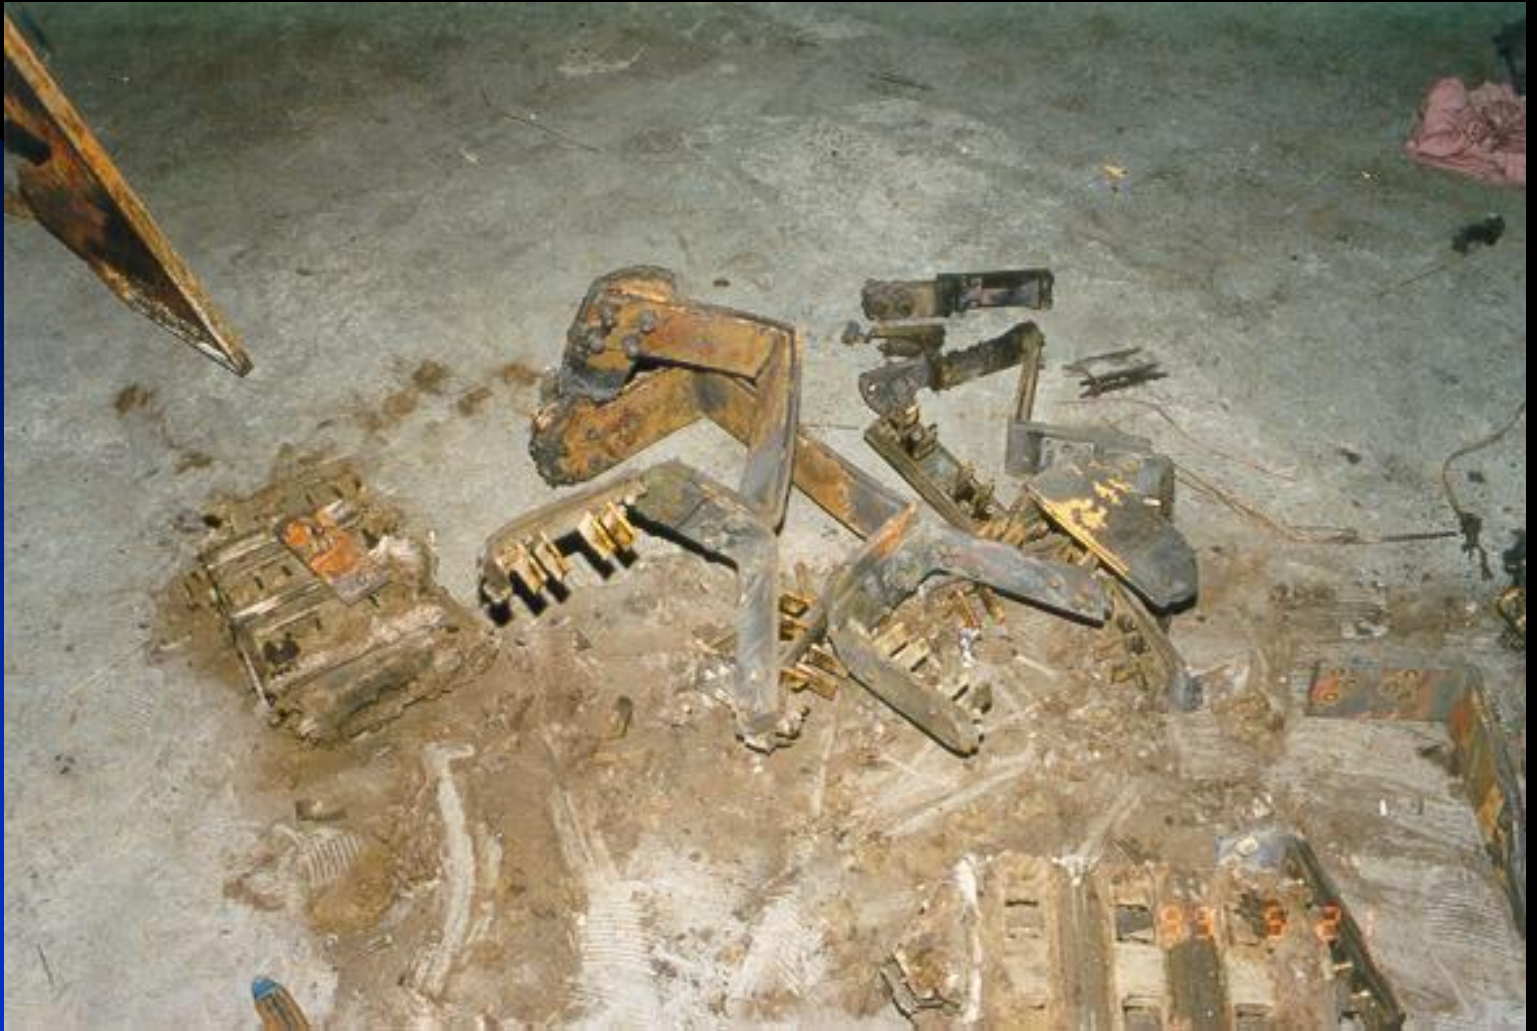
# Erosion of Busbars

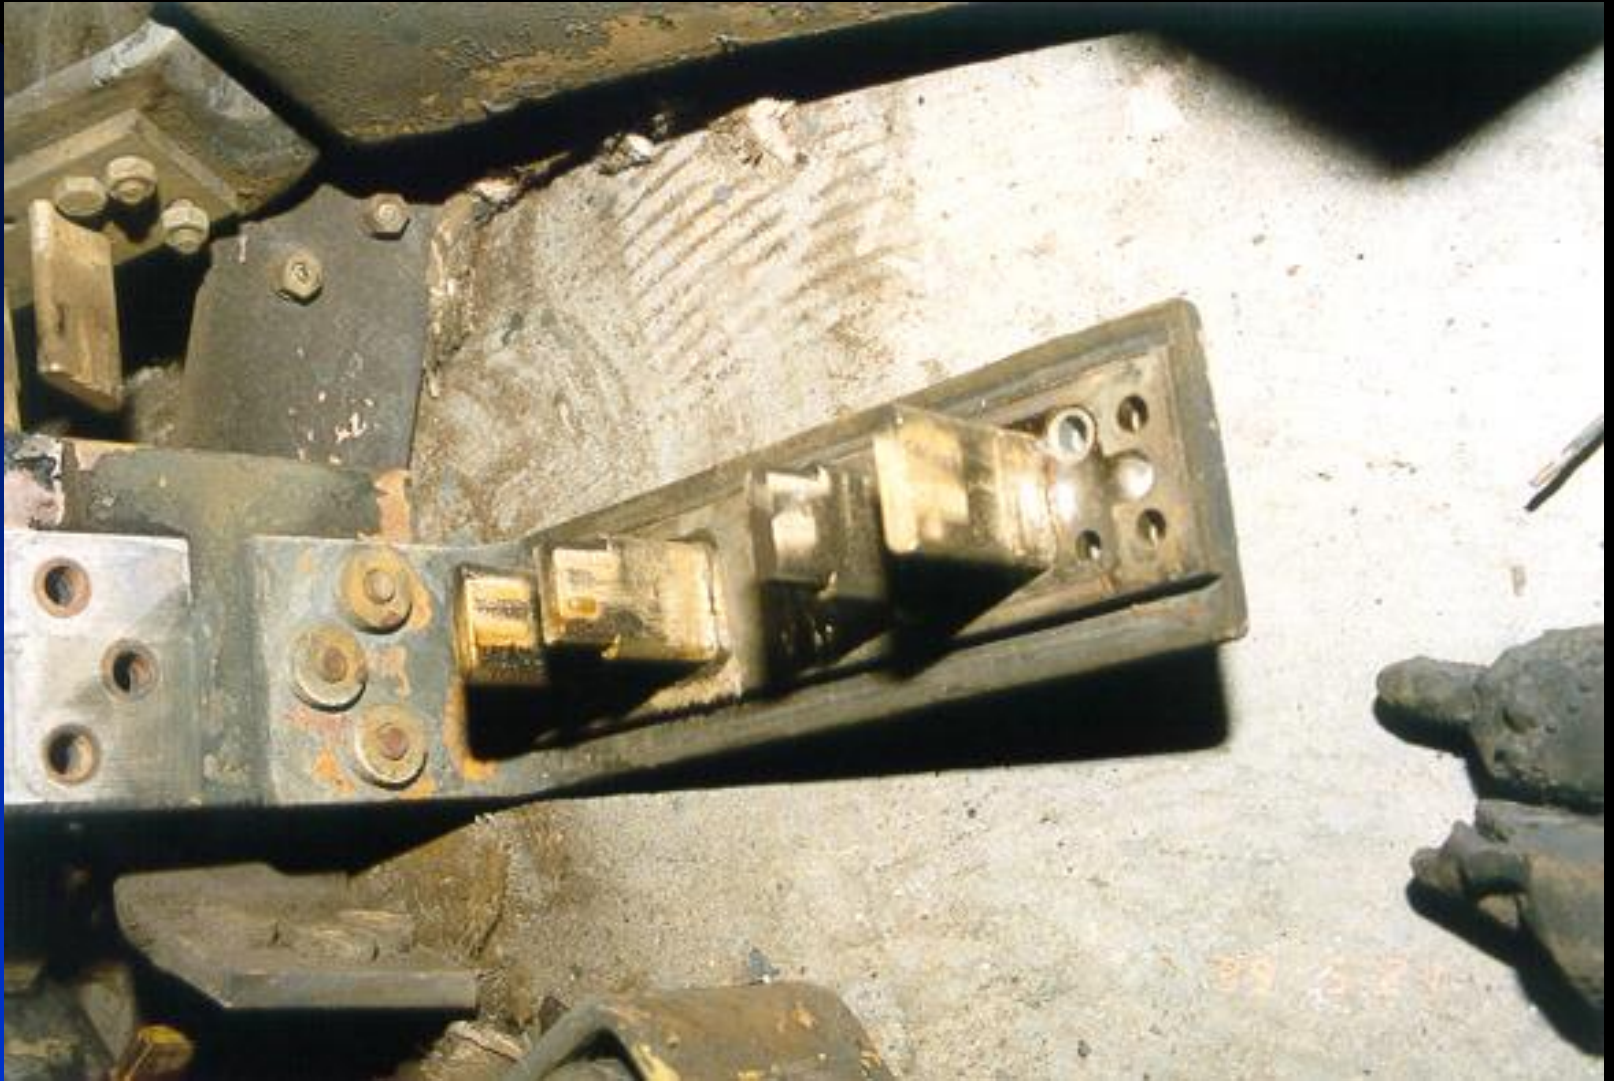
# Main Switch Contacts undamaged

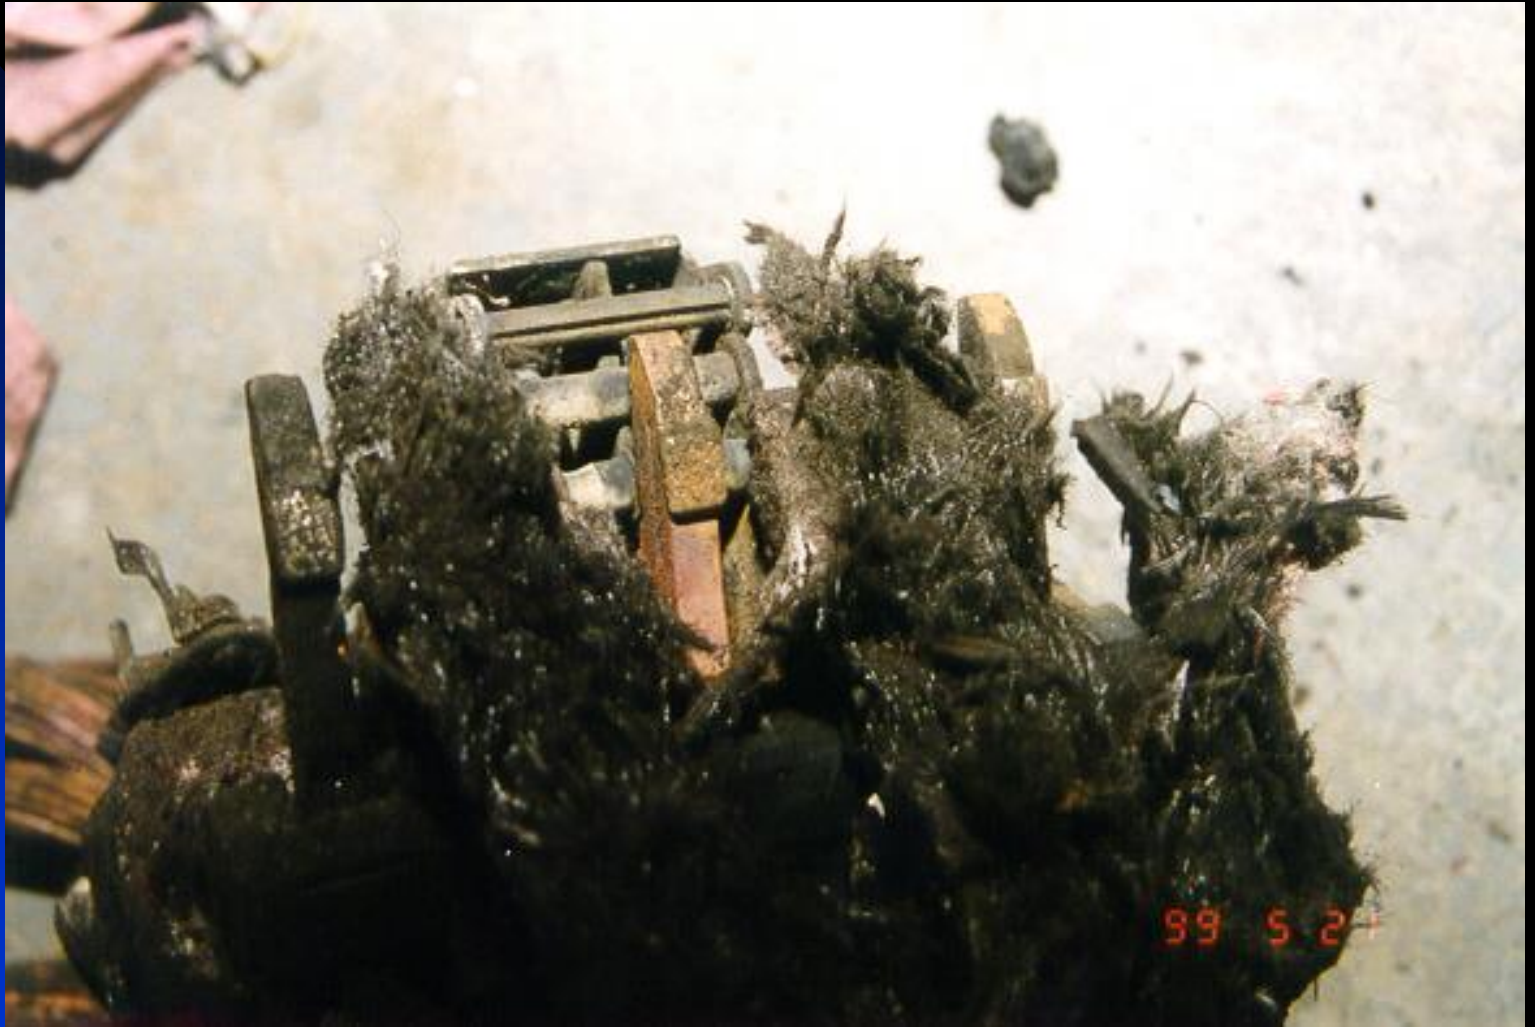
# Sub Circuit Breaker opened on Secondary Fault

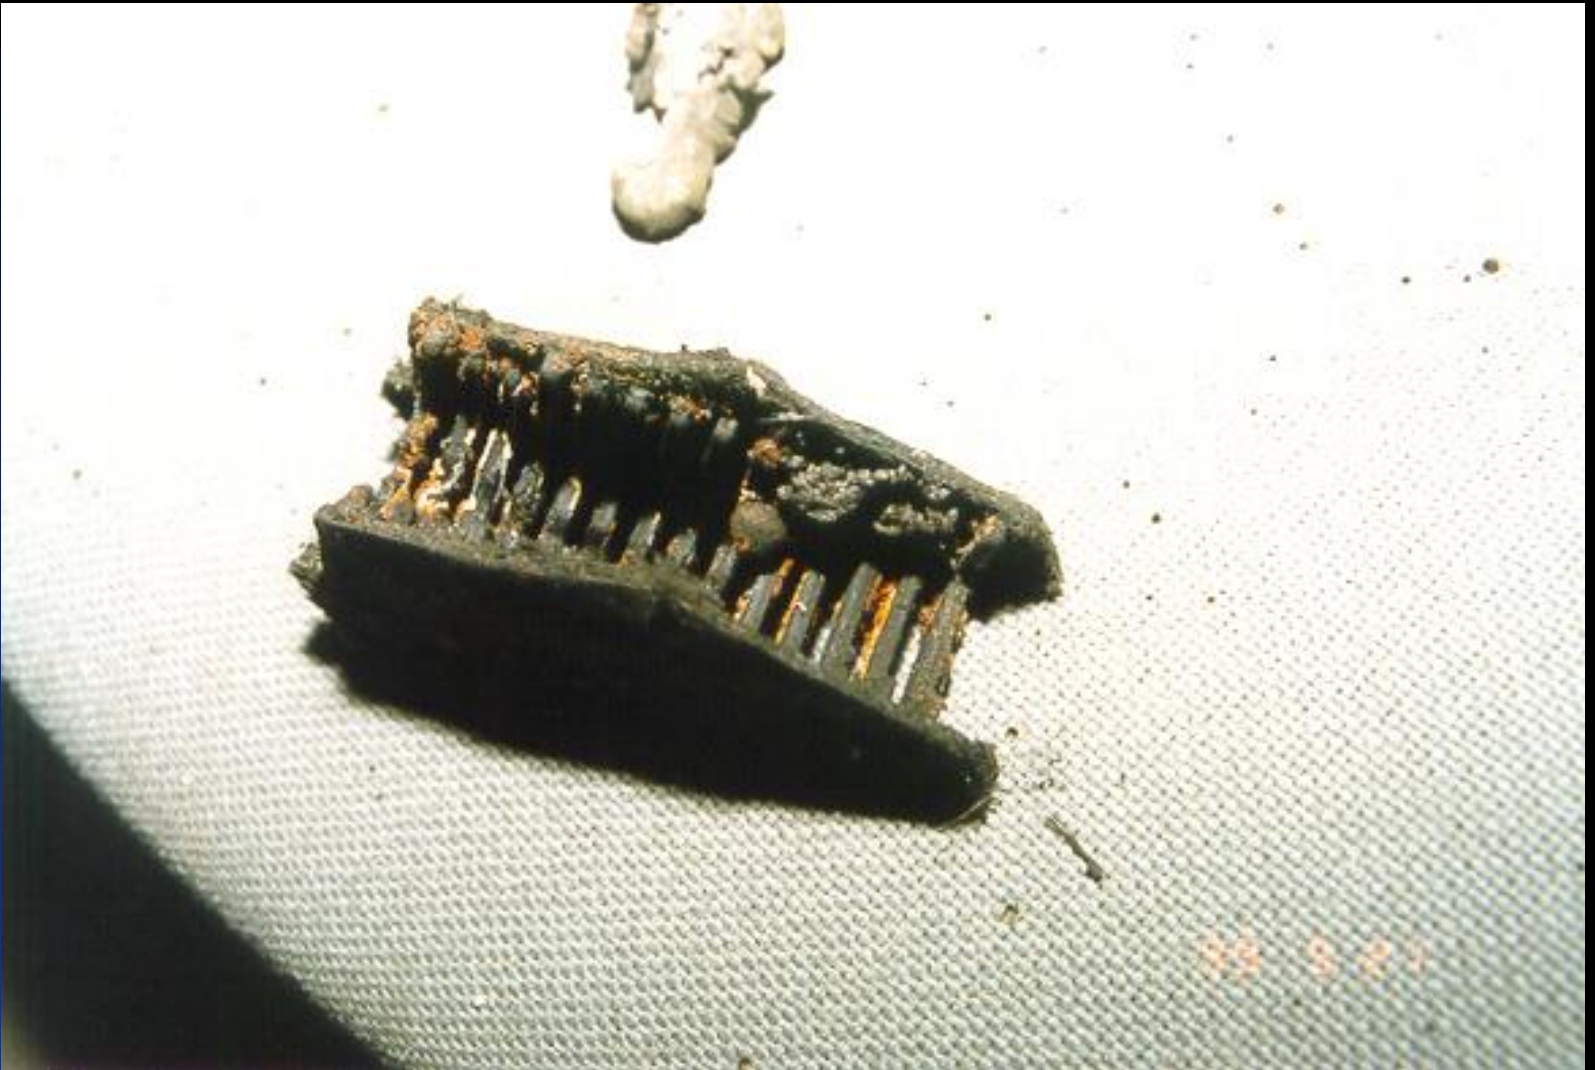
# Circuit Breaker Arc Chute
